# **Synthetic Fuel Lubricity Evaluations**

## **INTERIM REPORT TFLRF No. 367**

**U.S. Army TARDEC Fuels and Lubricants Research Facility (SwRI)  
Southwest Research Institute  
San Antonio, TX**

## EXECUTIVE SUMMARY

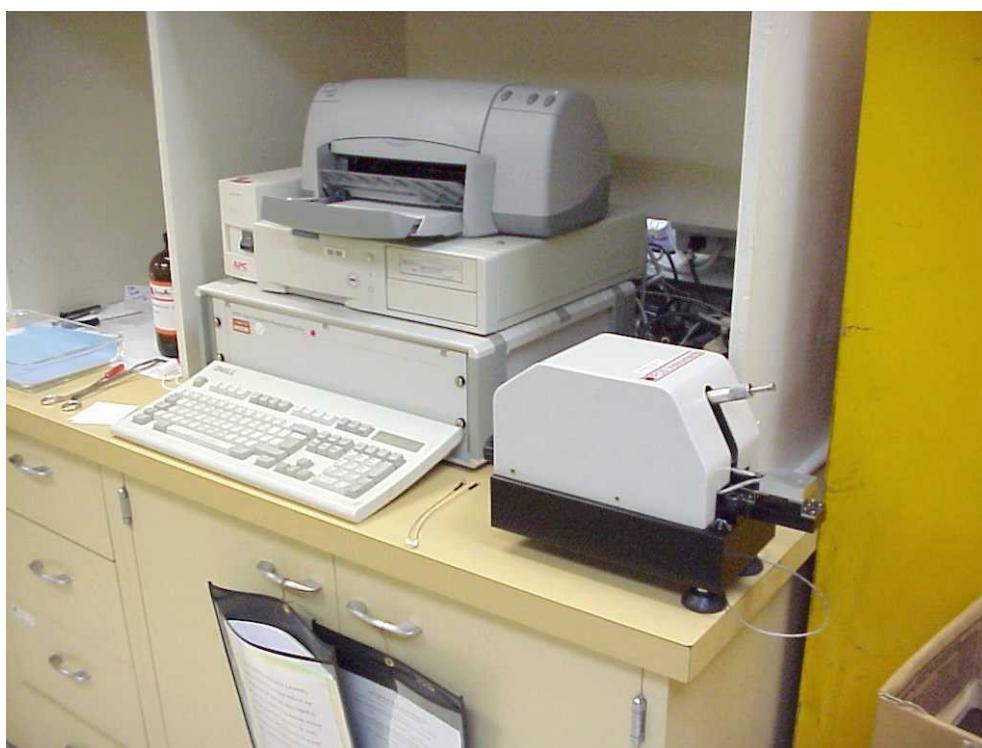
**Figure 2. High Frequency Reciprocating Rig (HFRR)**

- Ball-On-Cylinder Lubricity Evaluator (BOCLE) Test, ASTM D5001 (Figure 1)
- Scuffing Load BOCLE Test, ASTM D6078 (Figure 1)
- High Frequency Reciprocating Rig (HFRR) Test, ASTM D6079 (Figure 2)

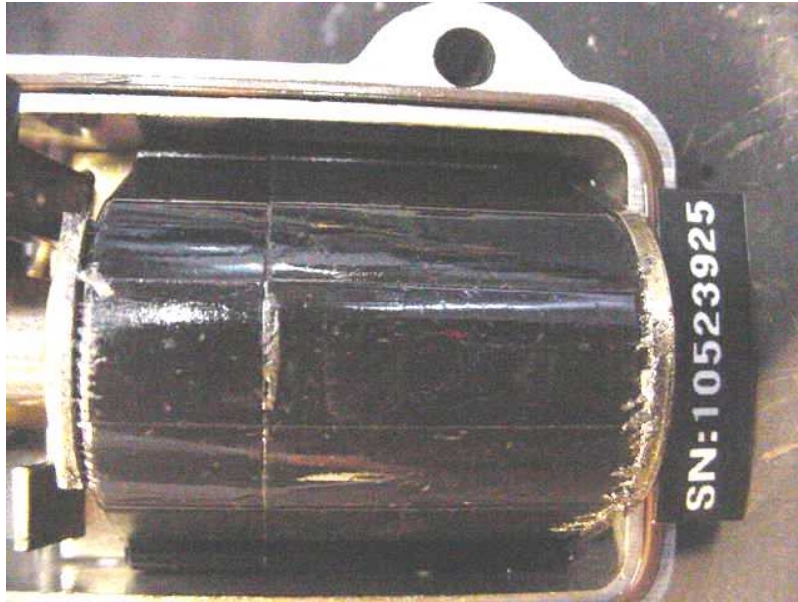
**Figure 7. Test 1 Pump 1: Metal Shavings on Solenoid**

Approximately 46 hours into the test, recorded data revealed that the inlet fuel pressure on Pump 1 increased to 11 psi and fuel flow decreased to 43cc, indicating that some event was causing extreme accelerated wear. Fuel flow continued to increase on Pump 2, indicating accelerated wear on this pump also. All other parameters remained at normal ranges; however, in order to preclude a complete seizure of the head and rotor assembly on Pump 1, the test stand was shut down at 95.6 hours of testing. The top cover on Pump 1 was removed for inspection. Slight metal debris was observed in the top chamber of the pump (Figure 6). Metal debris was also found in the top cover electric shut-off solenoid (Figure 7). Pump 1 was removed from the test stand, and testing resumed with Pump 2.

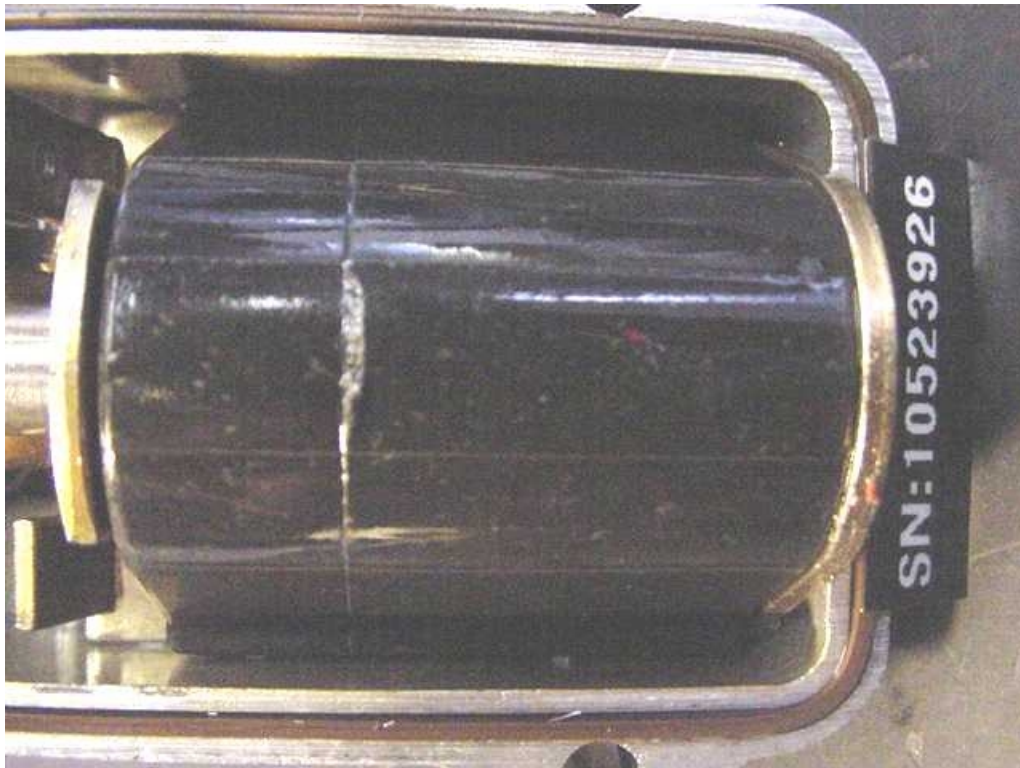
**Figure 9. Test 1 Pump 2: Debris Free Solenoid**

The test progressed until the test stand shut down after 151 hours. Logged data revealed that increased fuel outlet temperature triggered the automatic shutdown of the test stand solenoid, which is used to prevent imminent seizure of the head and rotor assembly. The top cover was removed from Pump 2; however, there was no evidence of wear debris in the chamber or the electric shut-off solenoid (Figures 8 and 9).

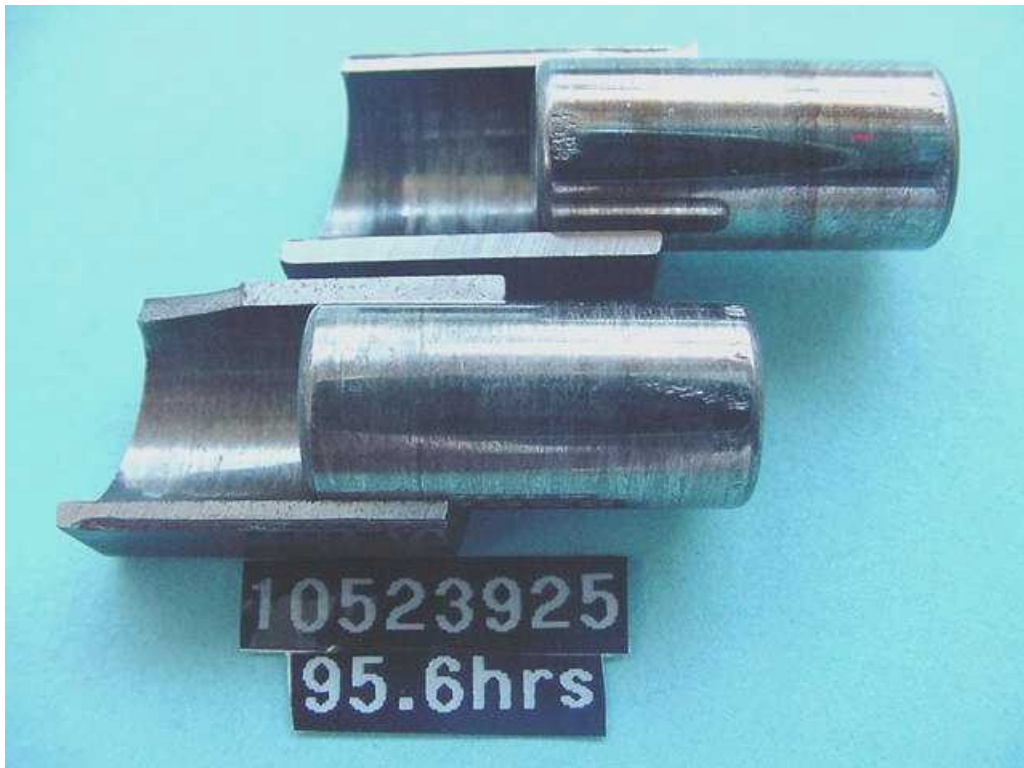
**Figure 10. Test 1 Pump 1: Chipped Shoe Wear**

Shoe and roller assemblies were excessively worn at the contact point with the leaf spring. The surface where the rollers make contact in the shoe assemblies on both pumps showed a galled surface, and the rollers were pitted and abraded. The back of the shoes (where the plunger contacts) showed excessive wear. One of the shoes on Pump 1 wore so excessively at the contact point with the leaf spring that it traveled away from the holder until it made contact with the cam ring assembly, causing a piece to chip off the end of the shoe.

Figures 10 through 15 show the shoe and roller assemblies, the back of the shoe holders, and the fuel plunger assemblies. The chipped shoe assembly can be seen in Figure 10 while the seized plunger is shown in Figure 14. Figure 16 shows deep scarring at the upper ports of the rotor shaft on Pump 1, and light scarring can be seen at the bottom of the rotor shaft in Figure 17.

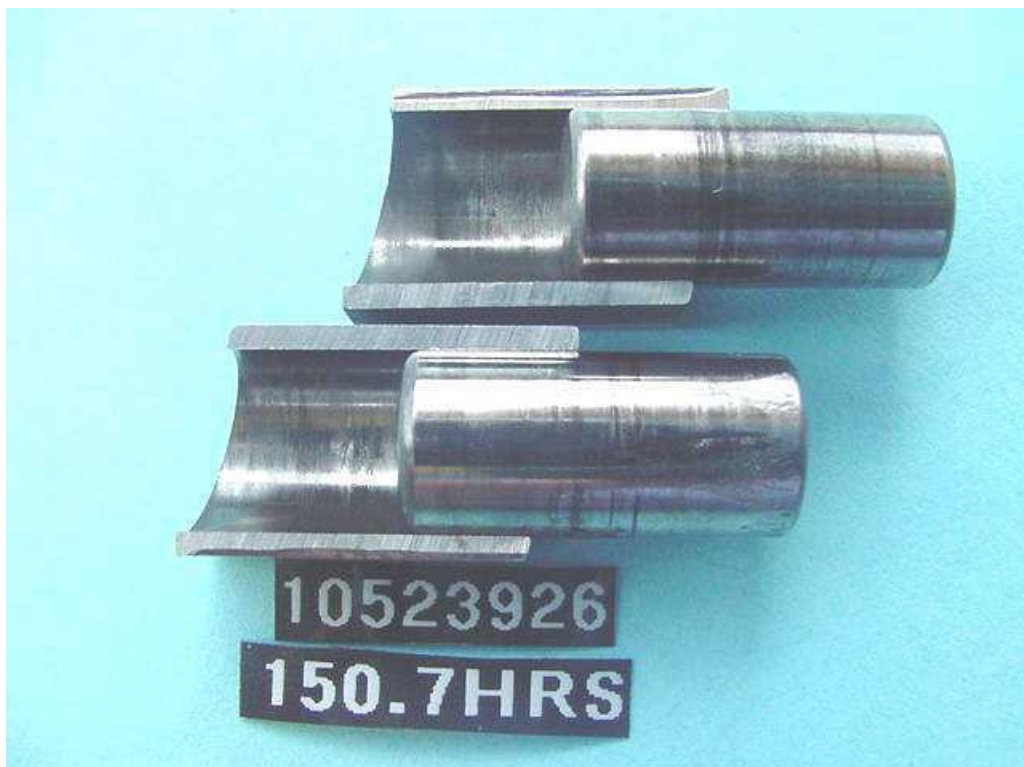
**Figure 11. Test 1 Pump 2: Shoe and Roller Wear**

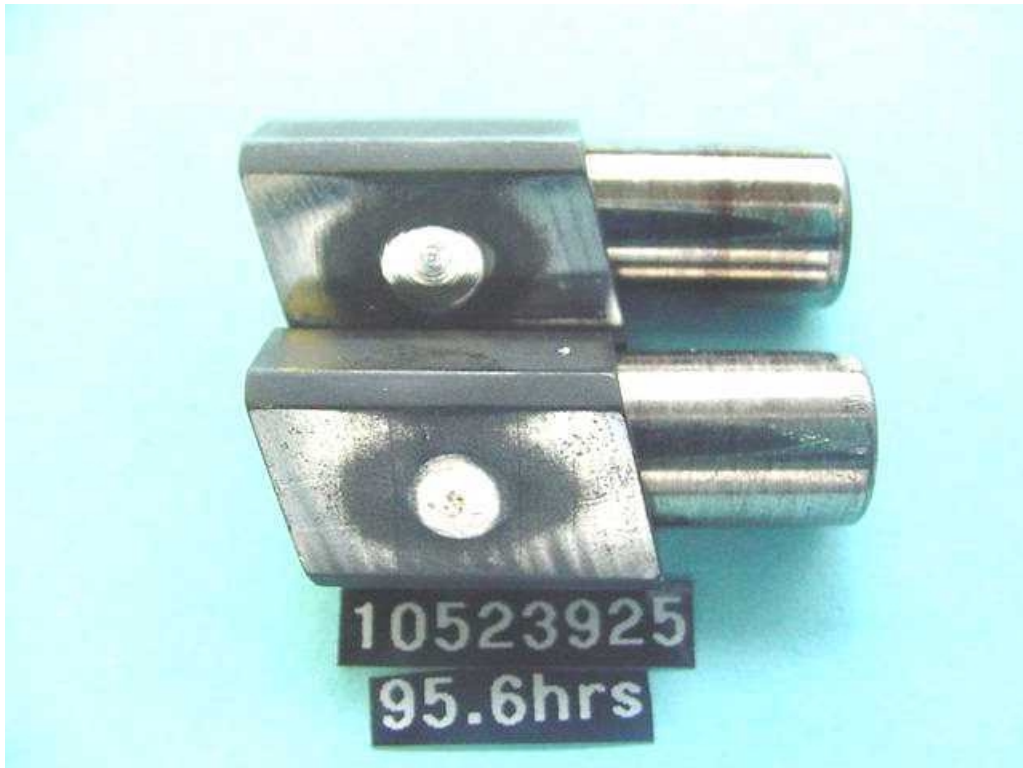
**Figure 12. Test 1 Pump 1: Shoe Back and Roller Wear**

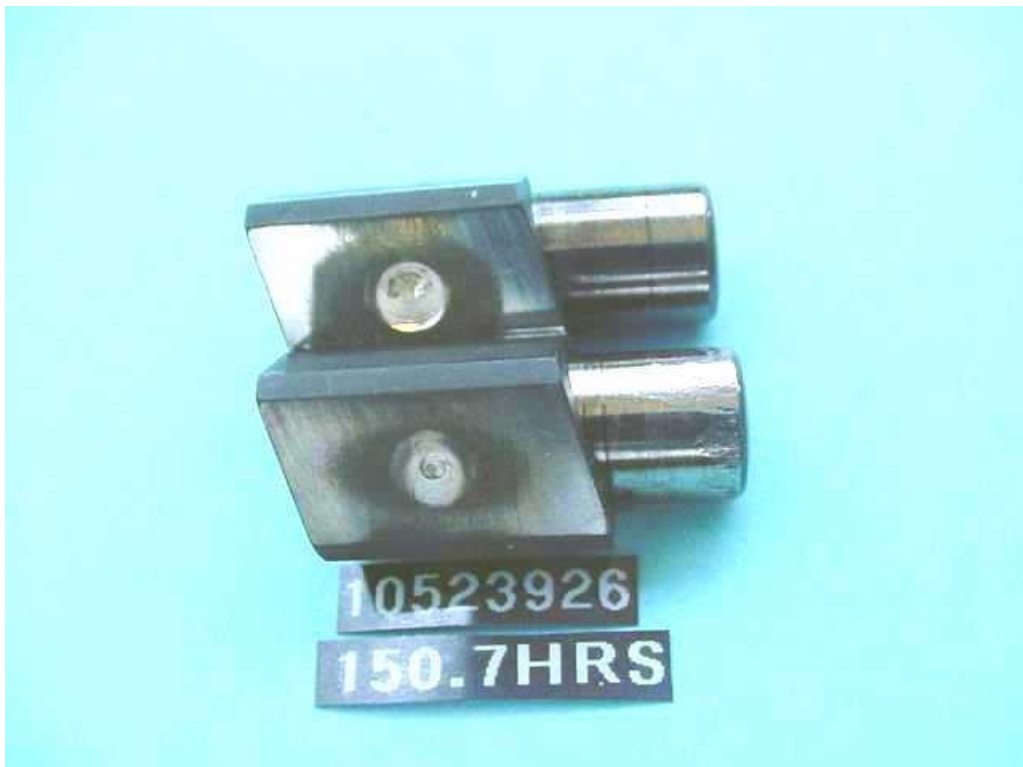
**Figure 13. Test 1 Pump 2: Shoe Back and Roller Wear**

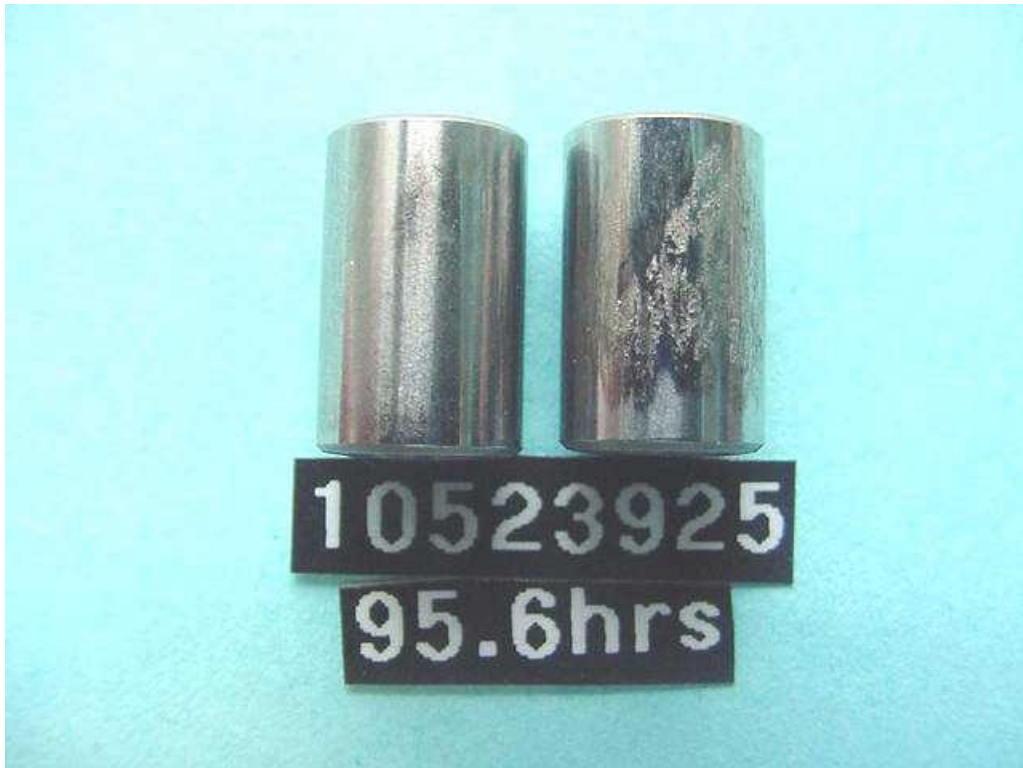
**Figure 14. Test 1 Pump 1: Plunger Assembly Wear**

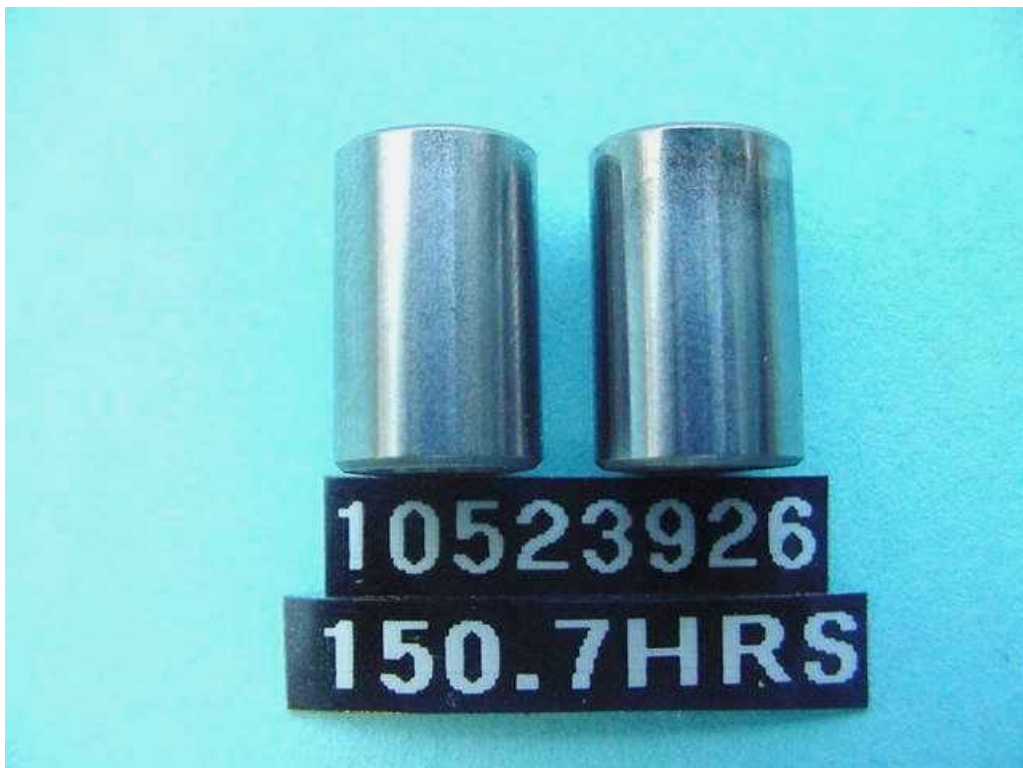
**Figure 15. Test 1 Pump 2: Plunger Assembly Wear**

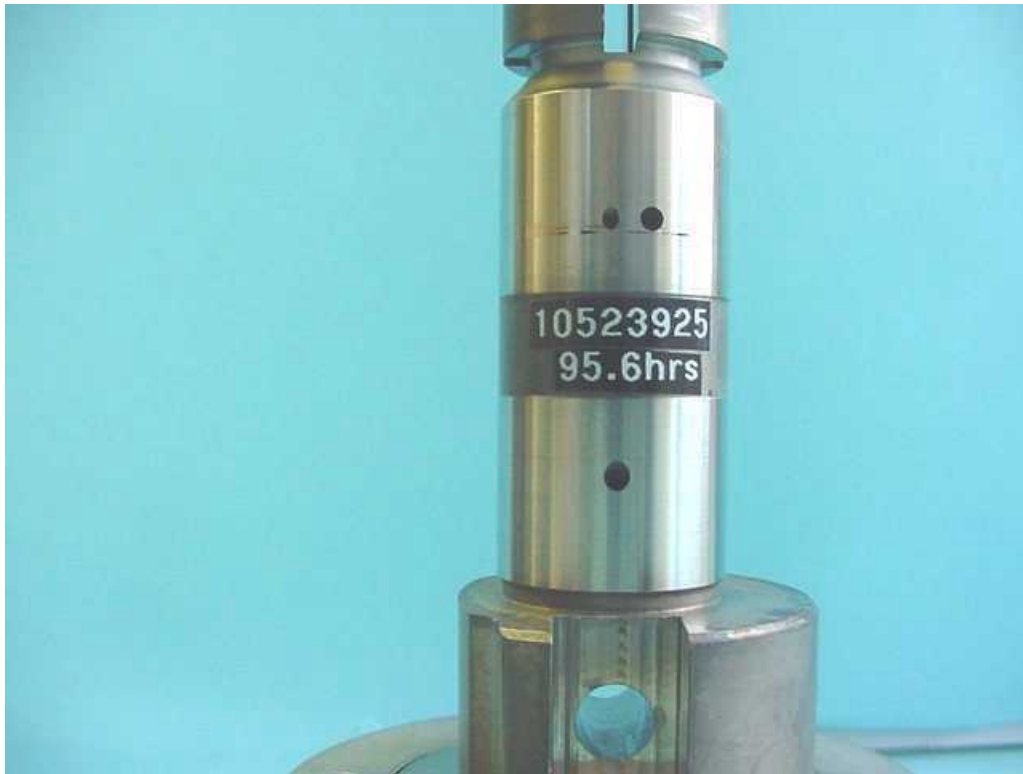
**Figure 16. Test 1 Pump 1: Rotor Shaft Wear**

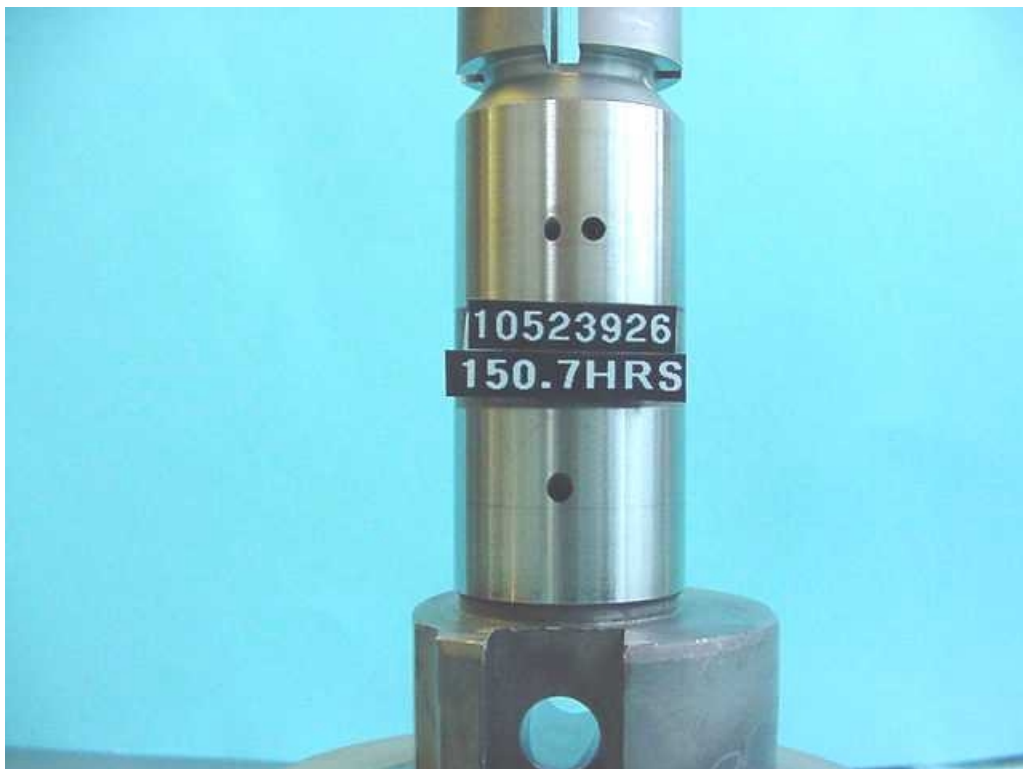
**Figure 17. Test 1 Pump 2: Rotor Shaft Wear**

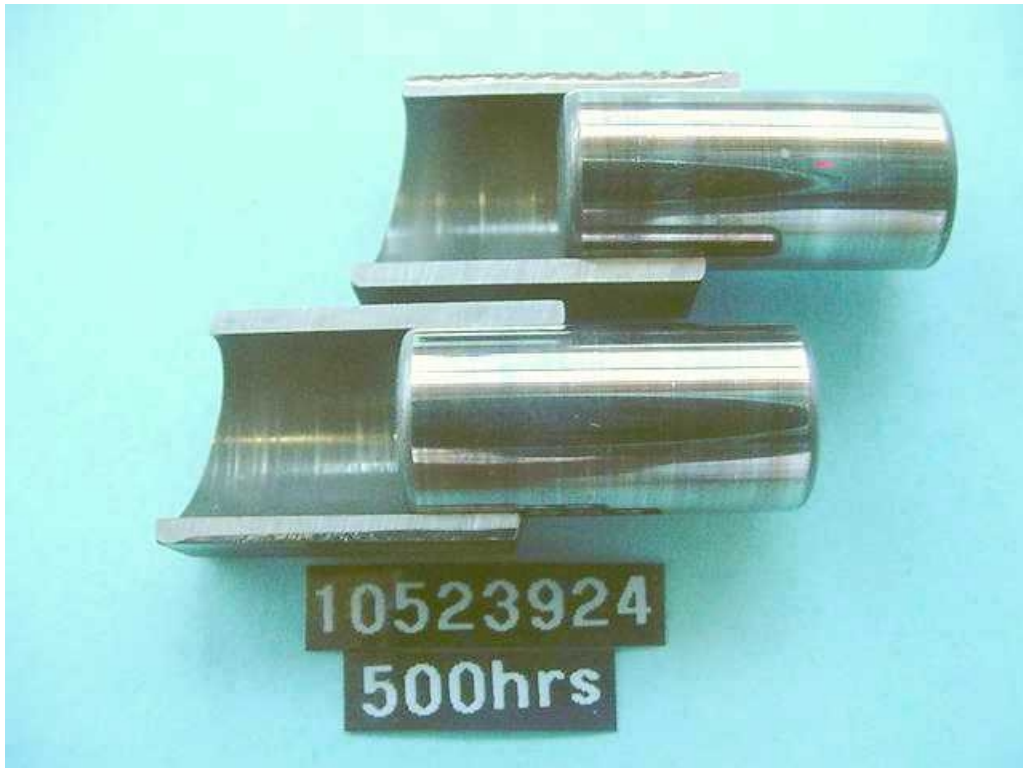
**Figure 19. Test 2 Pump 3: Shoe and Roller Assembly**

The effects of the light wear observed after 500 hours of testing would not be expected to be discernable in a typical vehicle installation. These pumps would be expected to operate normally at all sequences. Figures 19 through 22 are representative of the condition of components for all four aforementioned pumps. The shoe and roller assemblies for Pump 3 are shown in Figure 19. Figure 20 shows the back of the shoe assemblies of Pump 5 where the opposing plungers make contact. The opposing plungers for Pump 4 are shown in Figure 21, and the rotor shaft for Pump 6 is shown in Figure 22.

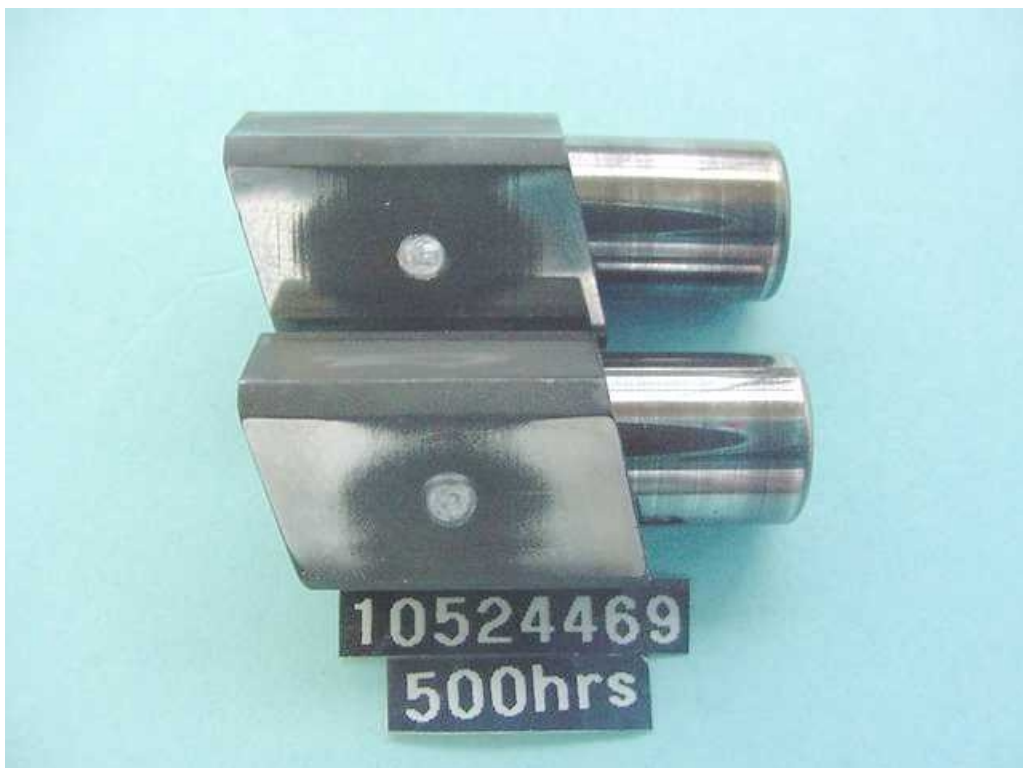
**Figure 20. Test 3 Pump 5: Back of Shoe and Roller Assembly**

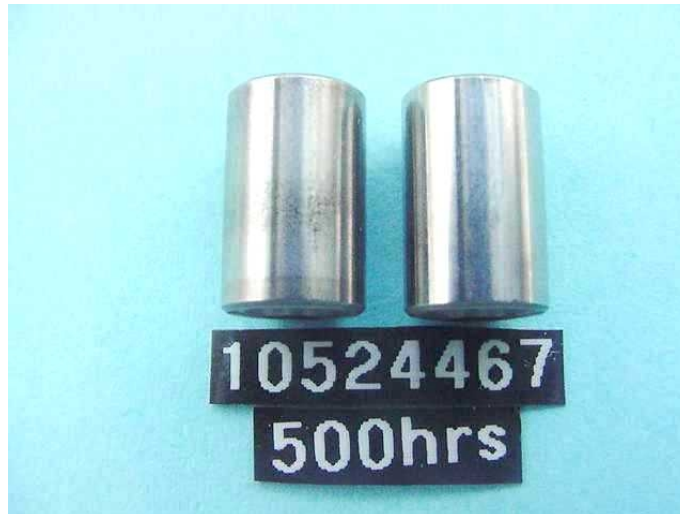
**Figure 21. Test 2 Pump 4: Plunger Assembly**

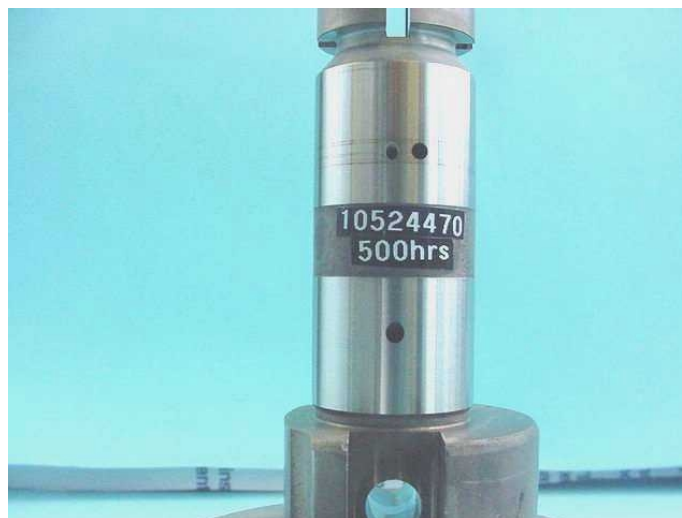
**Figure 22. Test 3 Pump 6: Rotor Shaft Assembly**
